# Manhole Inspection Summary

Manhole # S25M\_\_019MH

Insp Date: **3/5/08 1:02 PM**

**Location** Address: **1271 Washington Blvd** Cross Street: **South Carey Street**

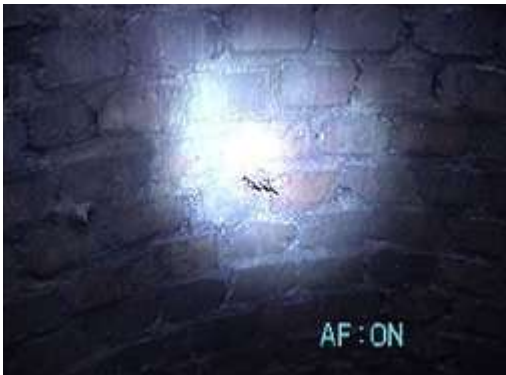
Defect 1

**Steps** Count: **0** Missing: **4** ☒ **Corroded**

missing steps

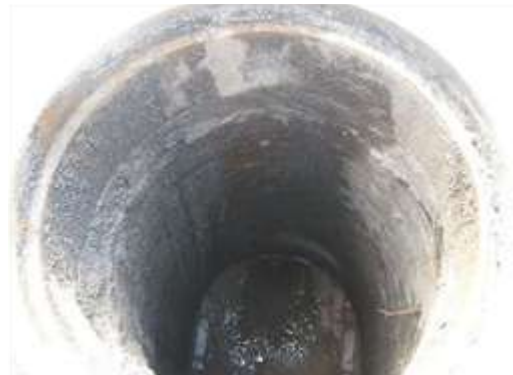
Defect 3

Infiltration: ☐ None ☐ Joint ☐ Cracks ☐ Mortar ☐ Roots ☒ **Wall**

infiltration from chimney/corbel and barrel

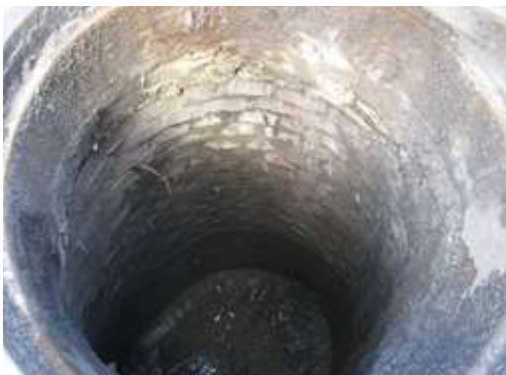
Defect 2

Infiltration: ☐ None ☐ Joint ☐ Cracks ☐ Mortar ☐ Roots ☒ **Wall**

infiltration from barrel and corbel

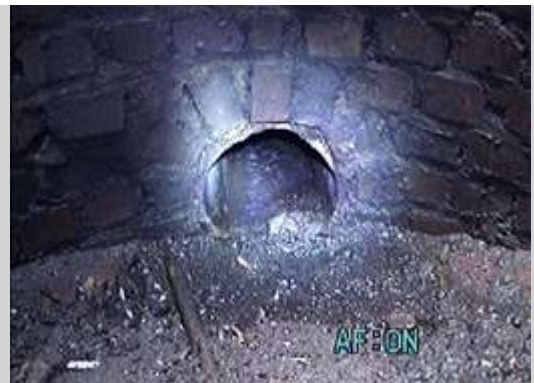
12 O'Clock Outflow

8 in. Circular Gravity Sewer  
Pipe Out @ 12 O'Clock

Deposits: ☐ None ☒ **Mud** ☐ Sludge ☐ Debris ☐ Grease

Silt Depth: **0.5** (in.) Deposits Extent: **Light**

Infiltration: **Evidence** Pipe Seal Cond: **Unknown**
